Reno/Virginia Peak (KRGX) Initial Dome Failure

19 December 2008

National Weather Service
Reno, NV

Reno/Virginia Peak (KRGX) Complete Dome Failure and Radar Dish Damage

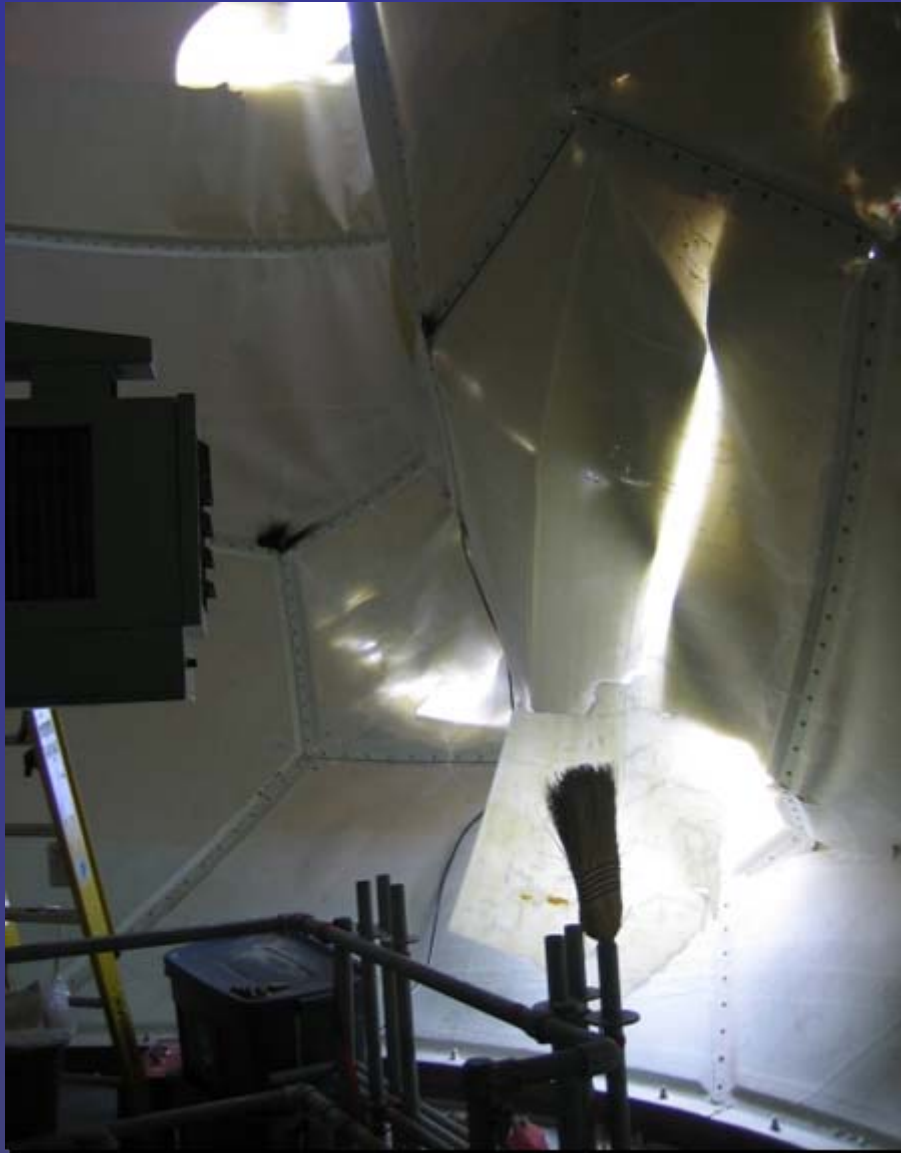
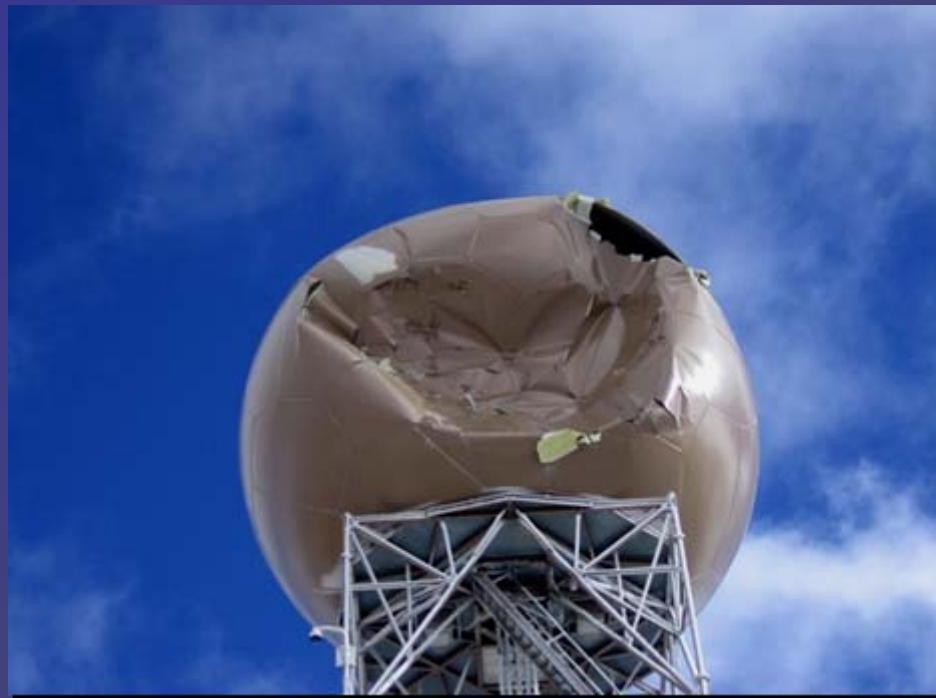
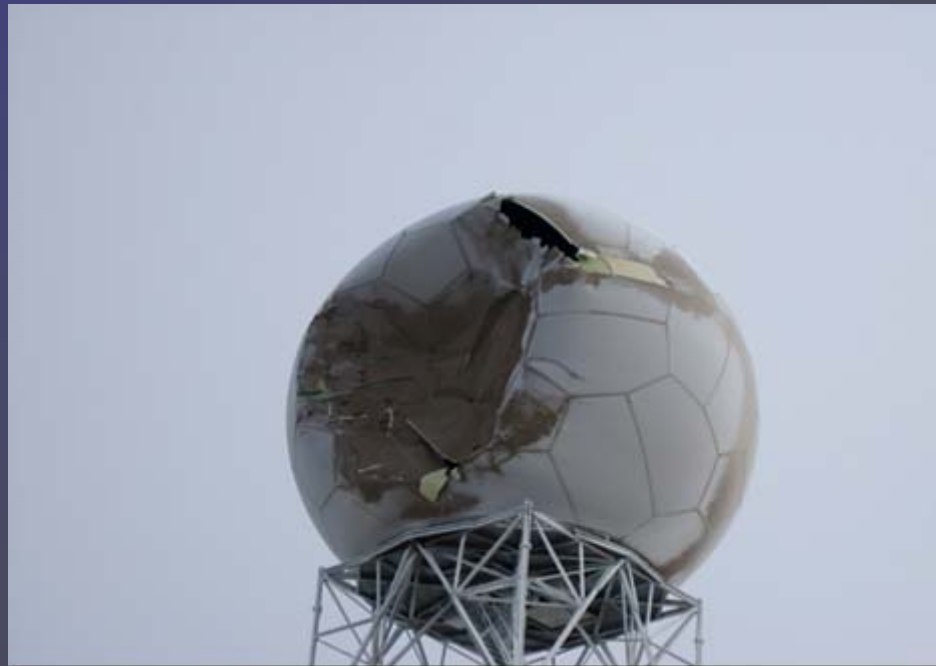
Photos Taken by NWS Reno
Electronics Team, on First Visit to
Radar After Dome Failure (19 Dec.)

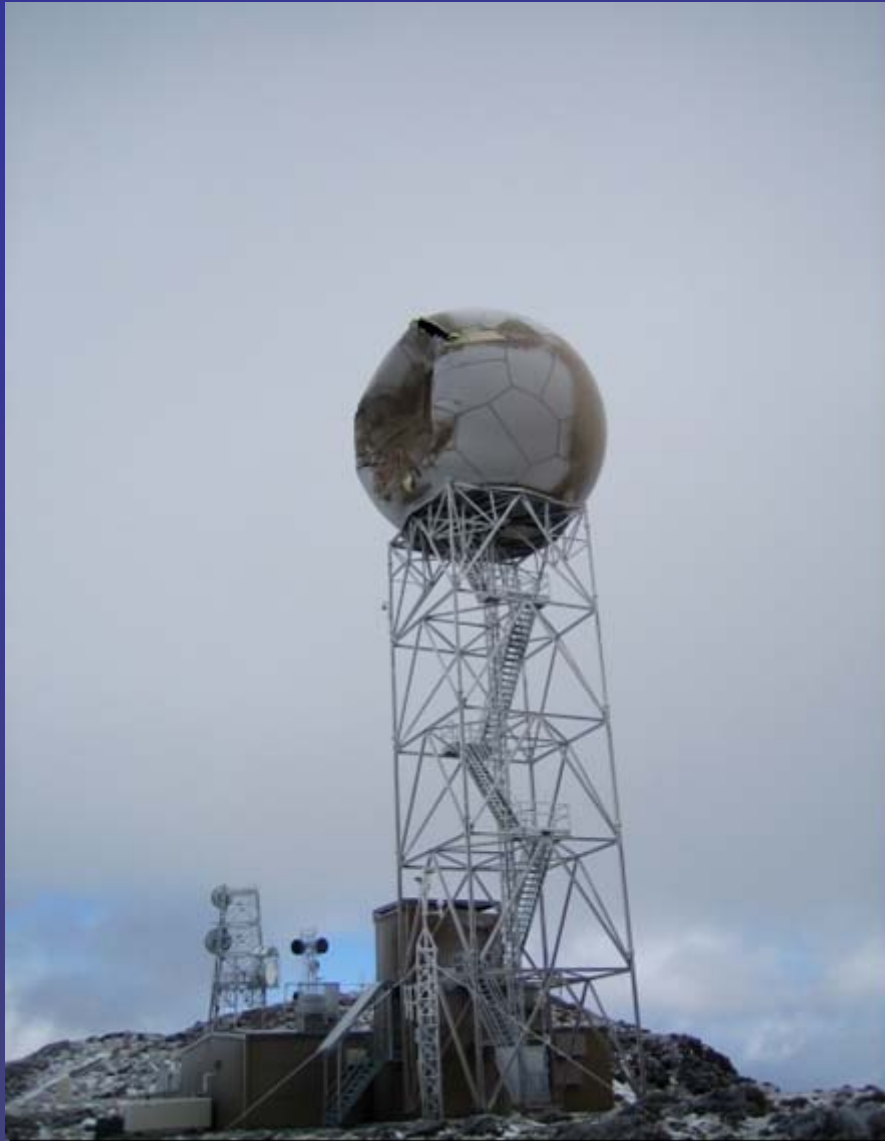
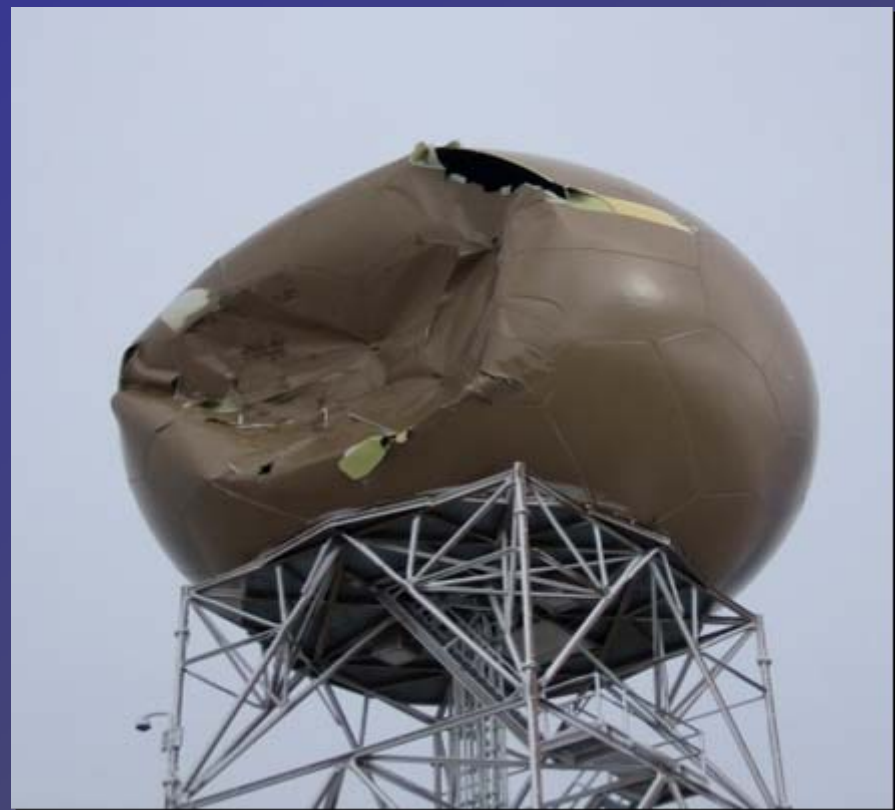
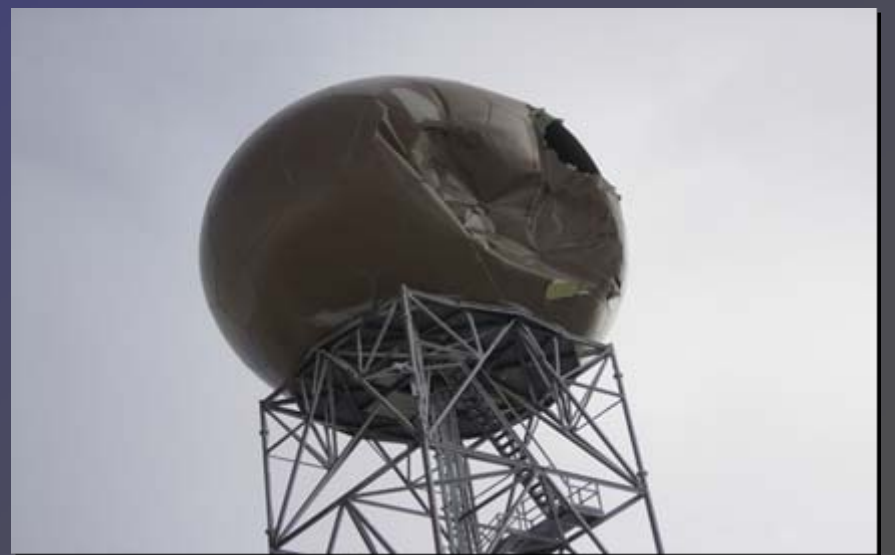
Photos Taken by NWS Reno
Electronics Team, on First Visit to
Radar After Dome Failure (19 Dec.)

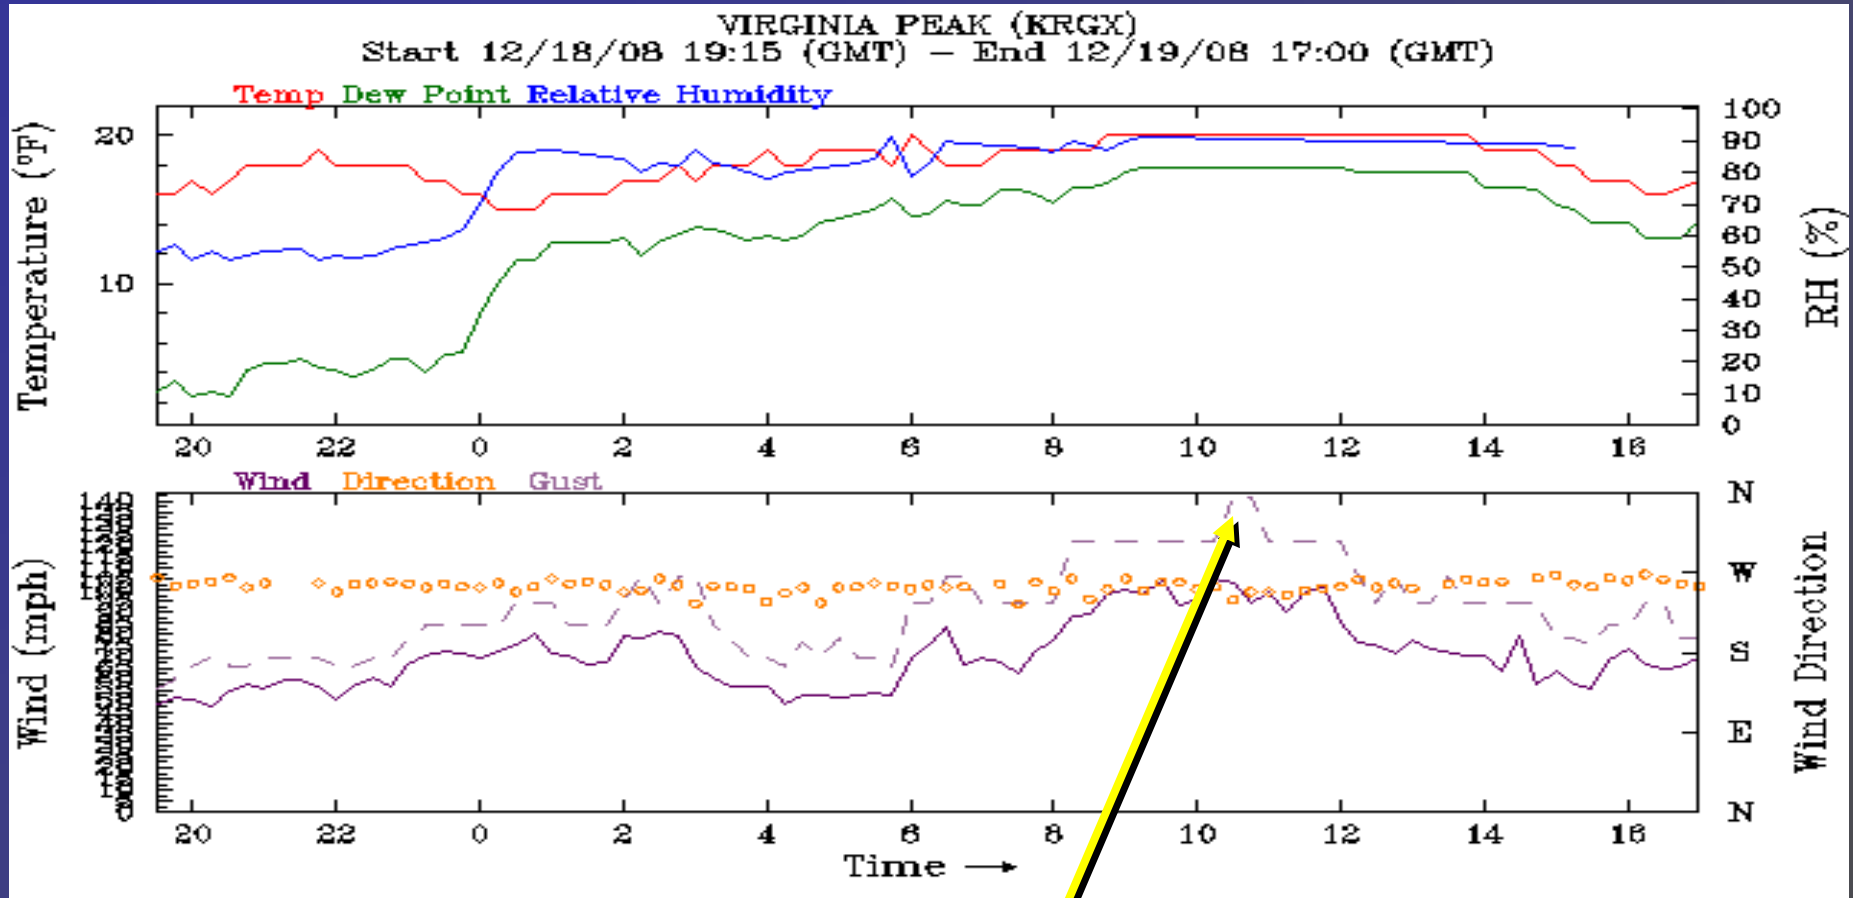
Virginia Peak Weather Data December 18-19, 2008

Elevation: 8299 ft MSL

140 mph Peak Gust Occurred at
the Same Time the Radar Failed

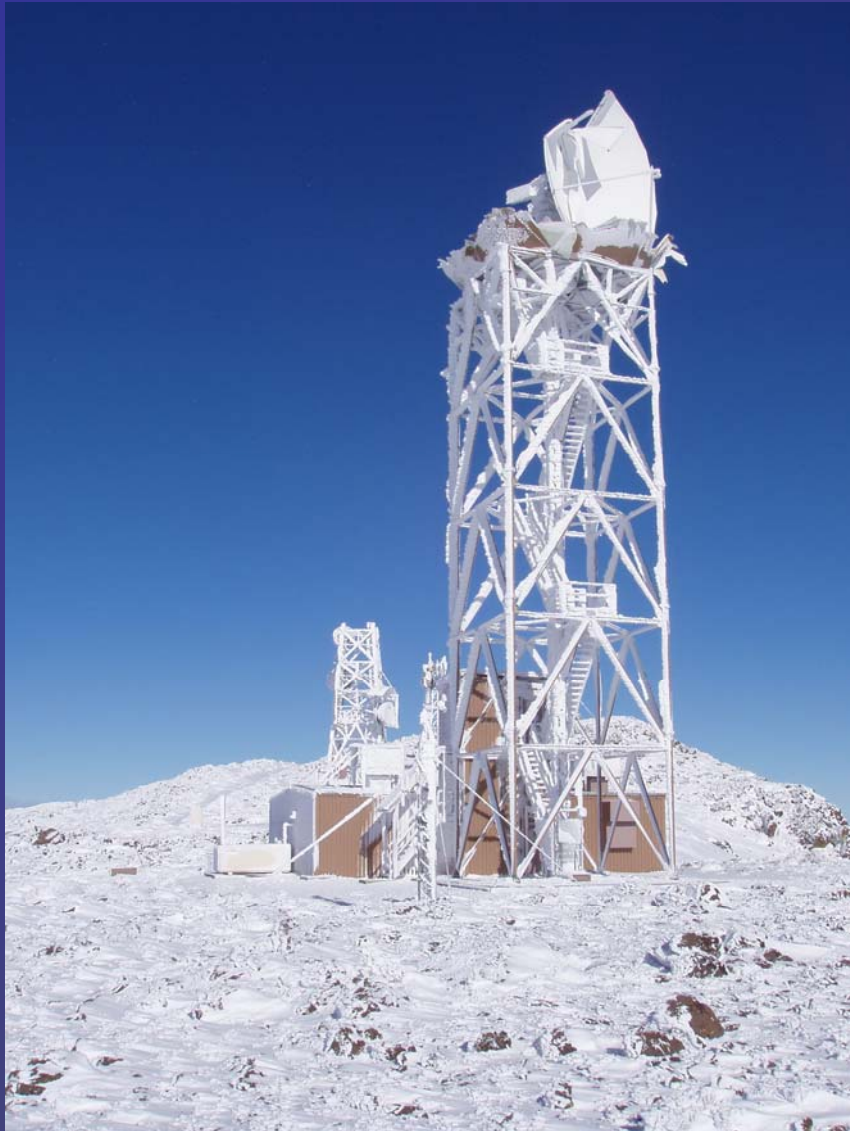
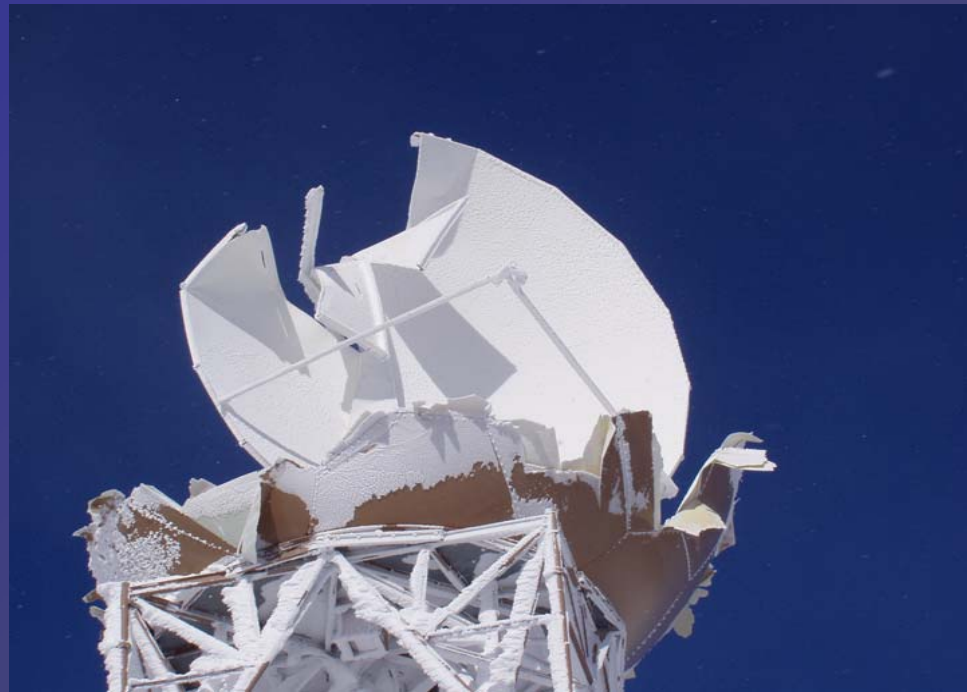
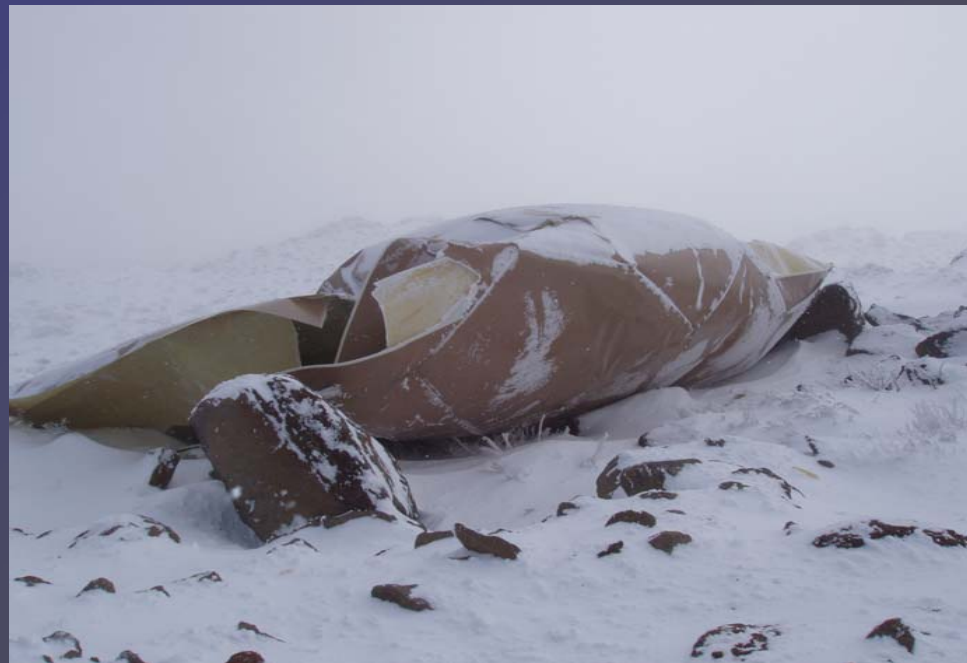
Photos Taken by NWS Reno
Electronics Team, on December
26th After Complete Dome Failure

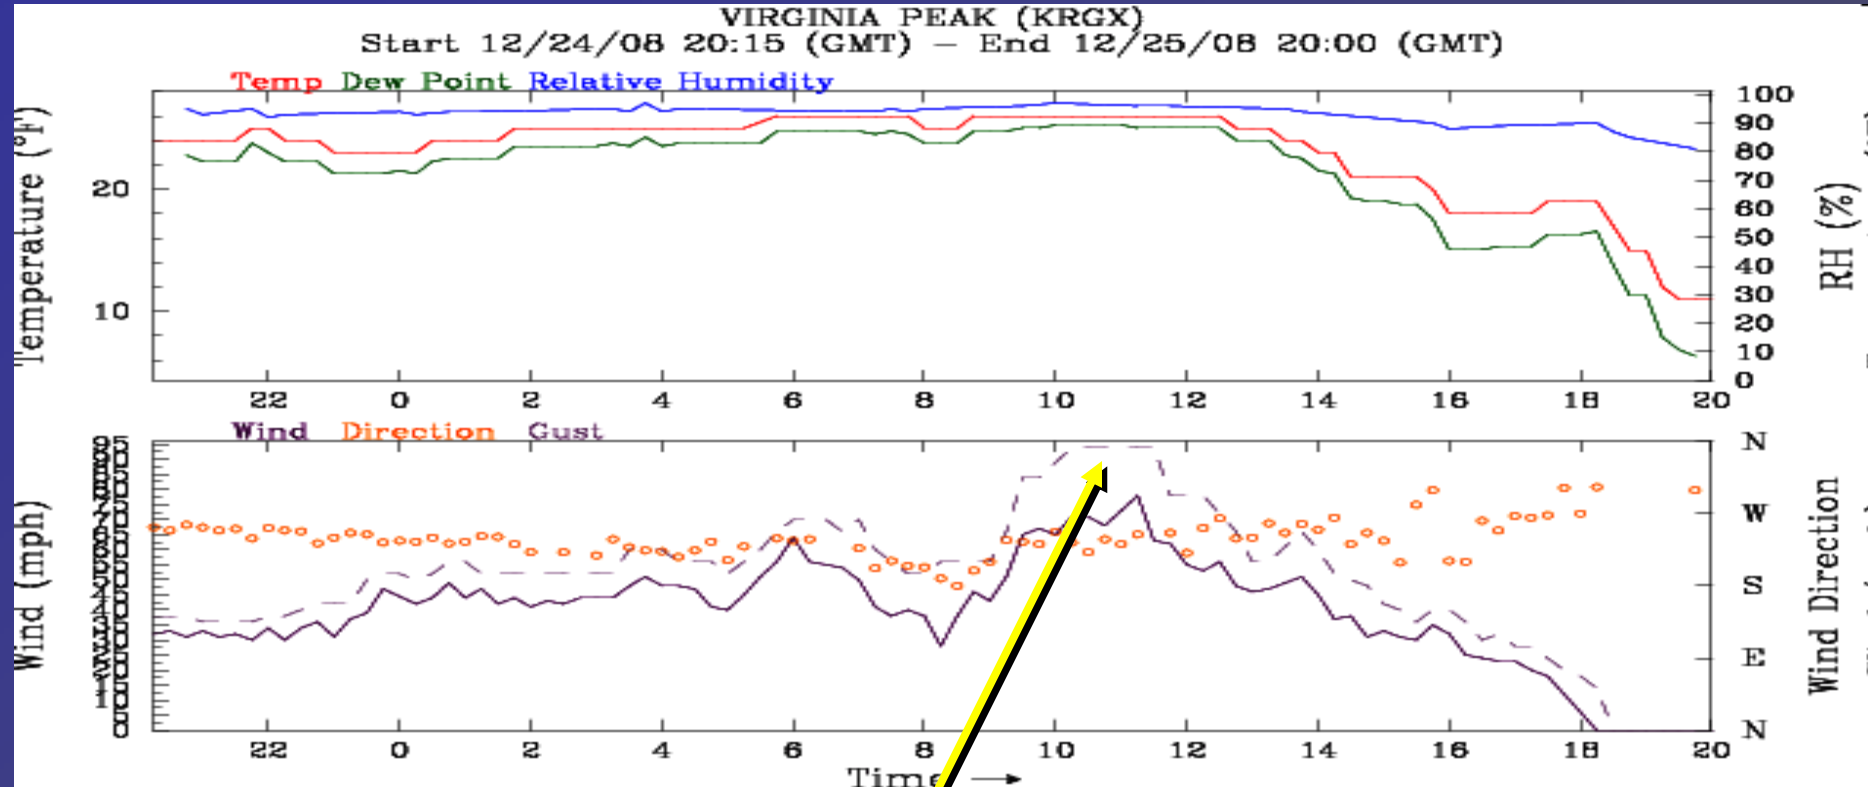
Virginia Peak Weather Data December 24-25, 2008

Elevation: 8299 ft MSL

95 mph Peak Gust Occurred Which
Likely Destroyed the Rest of the
Radome and Damaged the Radar Dish
